INDOOR AIR QUALITY ASSESSMENT

**Fallbrook Elementary School
25 DeCicco Drive
Leominster, MA 01453**

Prepared by:
Massachusetts Department of Public Health
Center for Environmental Health
Emergency Response Indoor Air Quality Program
October 2005

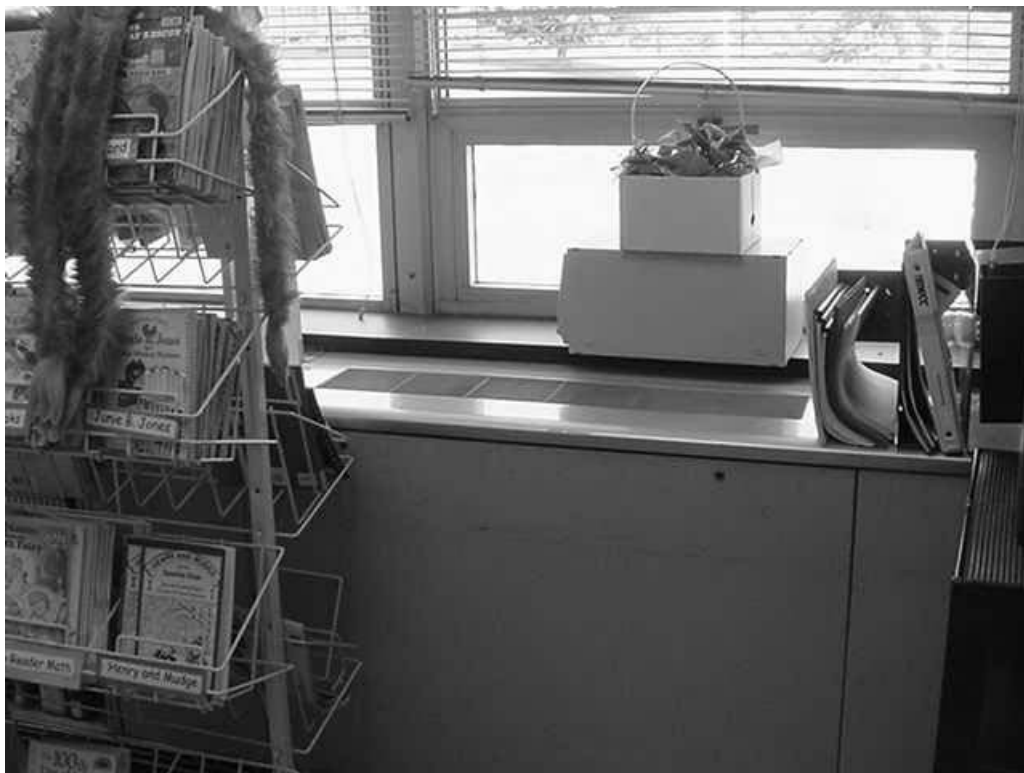
Picture 1

Fresh air in exterior classrooms is supplied by unit ventilator (univent) systems equipped with high efficiency pleated filters (Pictures 1 and 2). A univent is designed to draw air from outdoors through a fresh air intake located on the exterior wall of the building (Picture 3). Return air is drawn through an air intake located at the base of the unit ([Figure 1](#)). Fresh and return air are mixed, filtered, heated and provided to classrooms through an air diffuser located in the top of the unit. Several univents were deactivated during the assessment (Table 1); therefore, no mechanical means to introduce fresh air existed in these areas. Obstructions to airflow, such as papers and books stored on univents and bookcases, carts and desks in front of

Classroom Univent

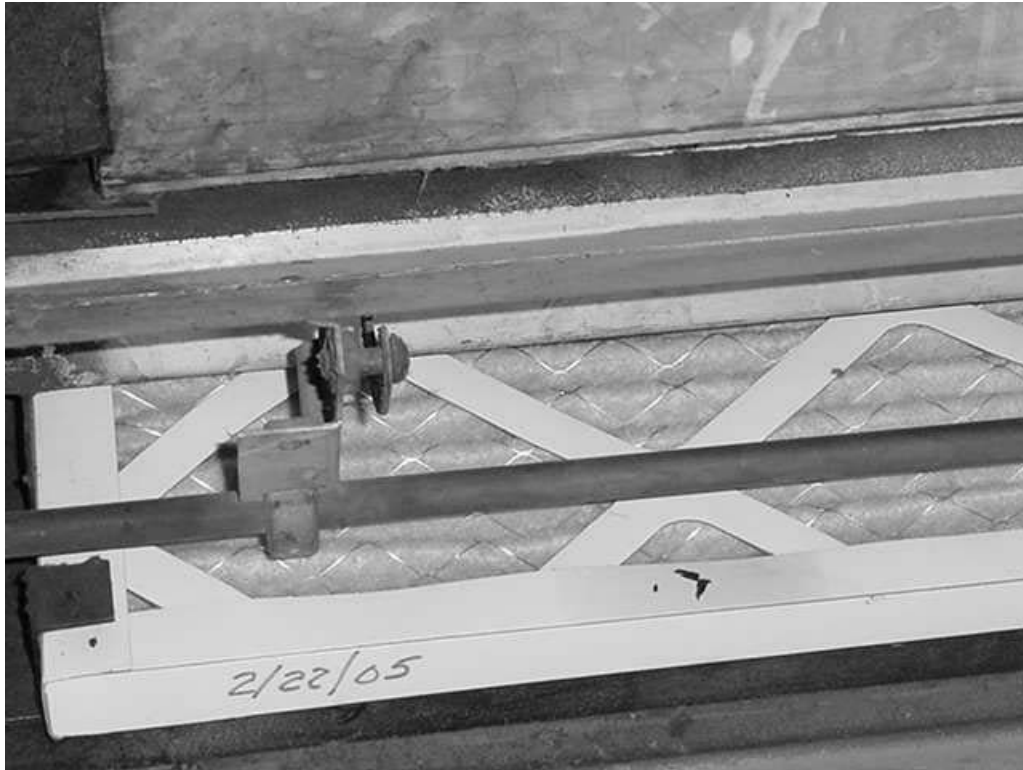
Picture 2

High Efficiency Pleated Air Filters in Univent

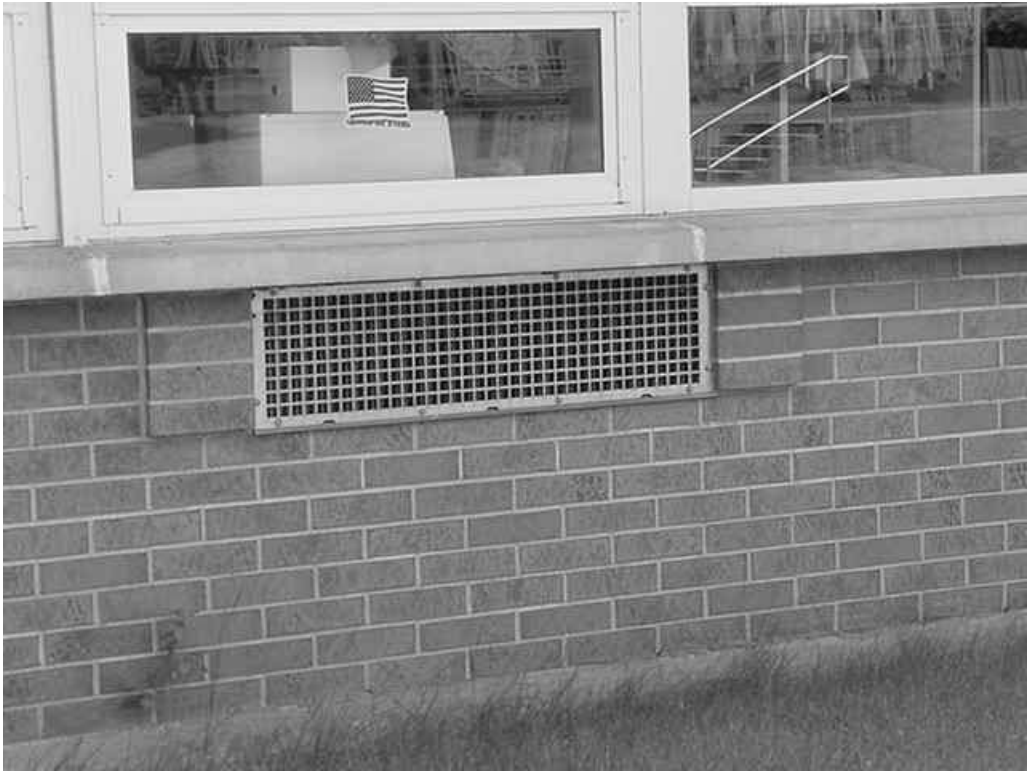
Picture 3

Univent Fresh Air Intake

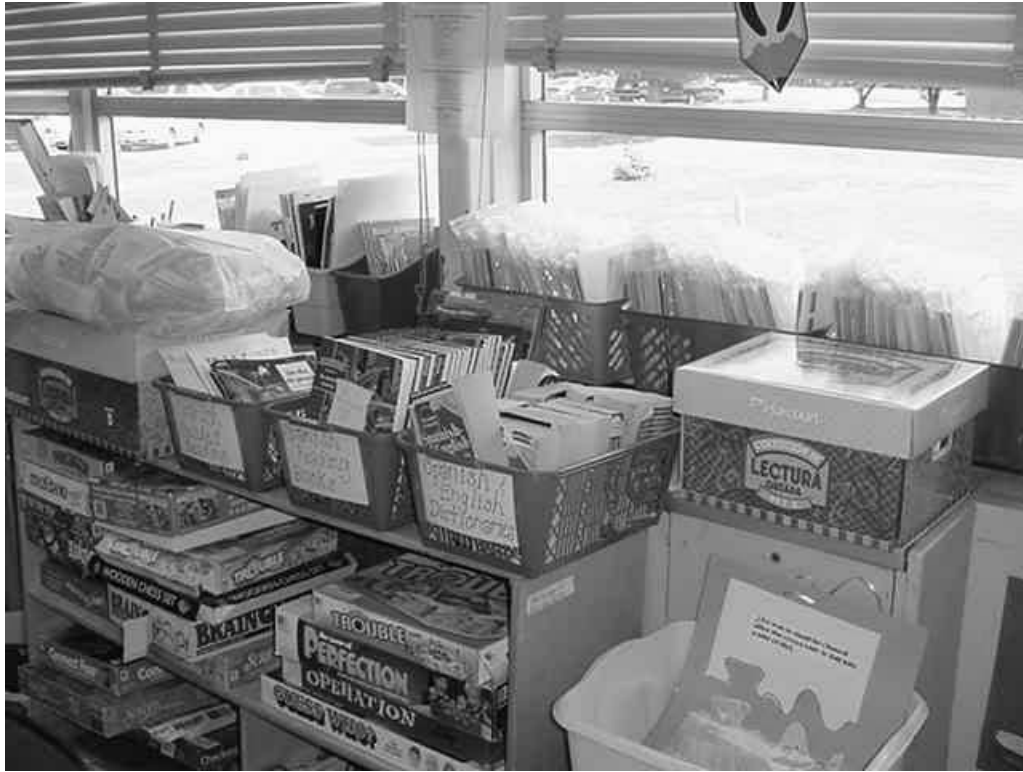
Picture 4

univent returns, were seen in several classrooms (Picture 4). In order for univents to provide fresh air as designed, units must be activated and remain free of obstructions.

Several other conditions that can affect indoor air quality were noted during the assessment. In some classrooms items were observed on windowsills, tabletops, counters, bookcases and desks (Pictures 4 and 14). The large number of items stored in classrooms provides a source for dusts to accumulate. These items (e.g., papers, folders, boxes) make it

Univent Obstructed by Items on and in Front of Unit

4. Remove all blockages from univents and exhaust vents to ensure adequate airflow.
5. Close classroom doors to maximize air exchange.
6. For buildings in New England, periods of low relative humidity during the winter are often unavoidable. Therefore, scrupulous cleaning practices should be adopted to minimize common indoor air contaminants whose irritant effects can be enhanced when the relative humidity is low. To control for dusts, a high efficiency particulate arrestance (HEPA) filter equipped vacuum cleaner in conjunction with wet wiping of all surfaces is recommended. Avoid the use of feather dusters. Drinking water during the day can help ease some symptoms associated with a dry environment (throat and sinus irritations).

14. Relocate or consider reducing the amount of materials stored in classrooms to allow for more thorough cleaning. Clean items regularly with a wet cloth or sponge to prevent excessive dust build-up.

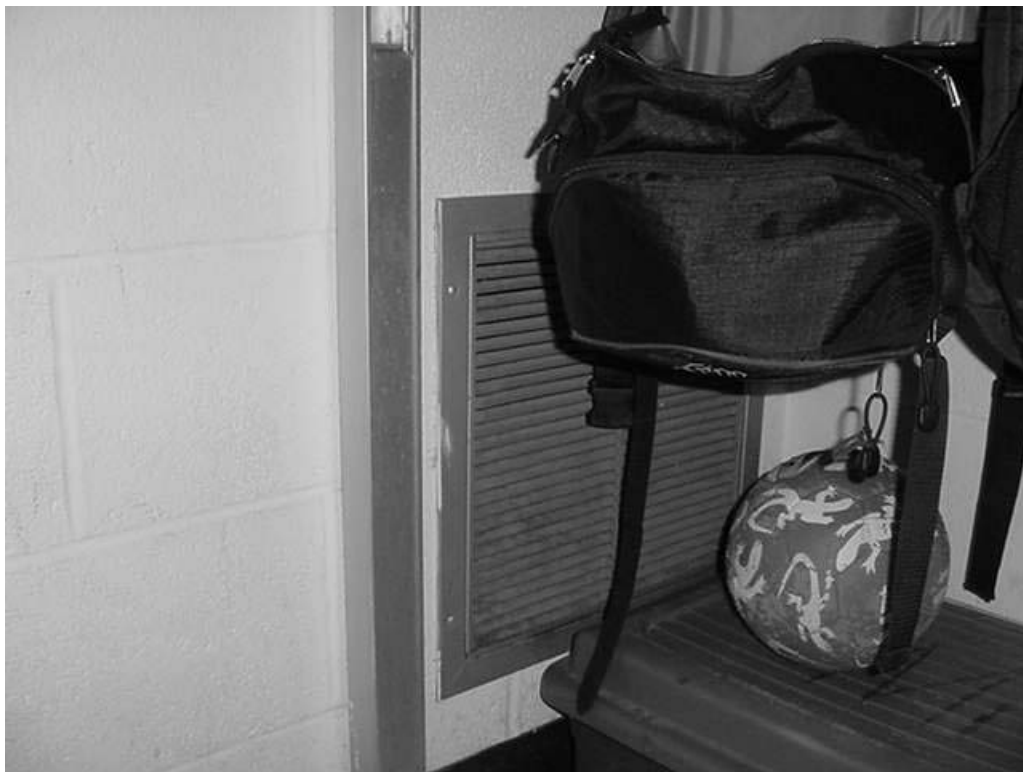
Picture 5

Exhaust ventilation in classrooms is provided by wall-mounted vents (Picture 5) powered by rooftop motors (Picture 6). Exhaust vents were either not drawing or drawing weakly in several areas (Table 1). Mr. Wood reported that two exhaust fans were on a repair list. As with the univents, a number of exhaust vents were also obstructed by desks, bookcases and other items (Picture 7). In order to function properly, exhaust vents must be activated and remain free of obstructions.

Wall-Mounted Exhaust Vent

2. Continue with plans to make repairs to the exhaust system.
3. Use openable windows in conjunction with mechanical ventilation to facilitate air exchange. Care should be taken to ensure windows are properly closed at night and weekends to avoid the freezing of pipes and potential flooding.

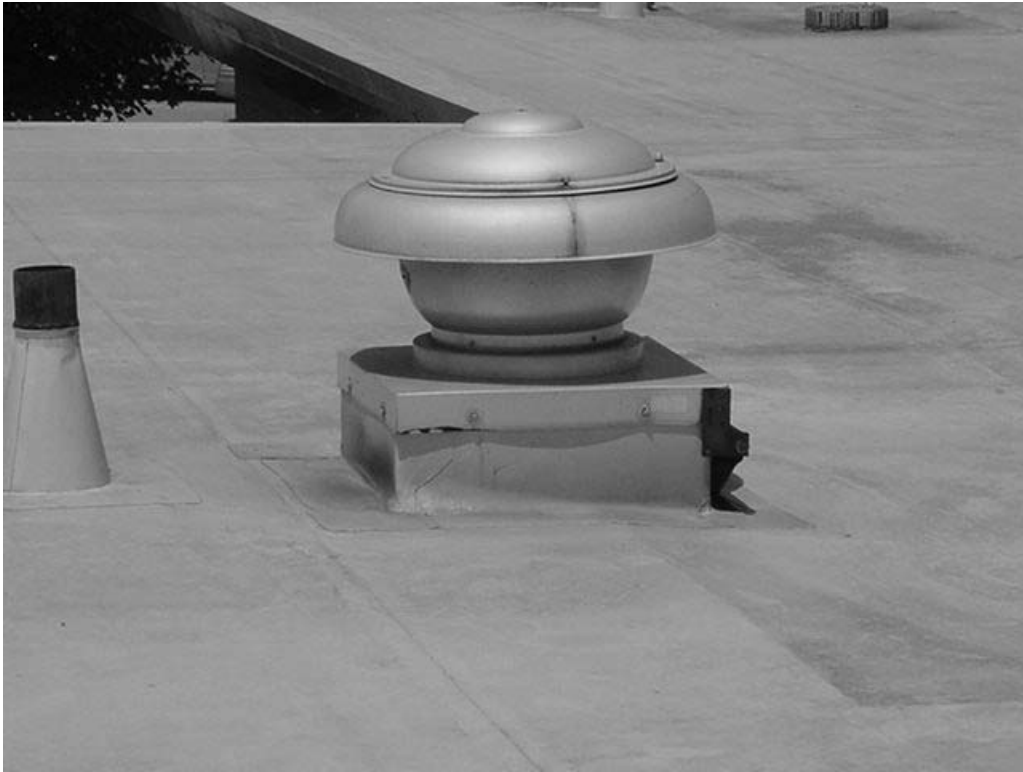
Picture 6

Rooftop Exhaust Motor

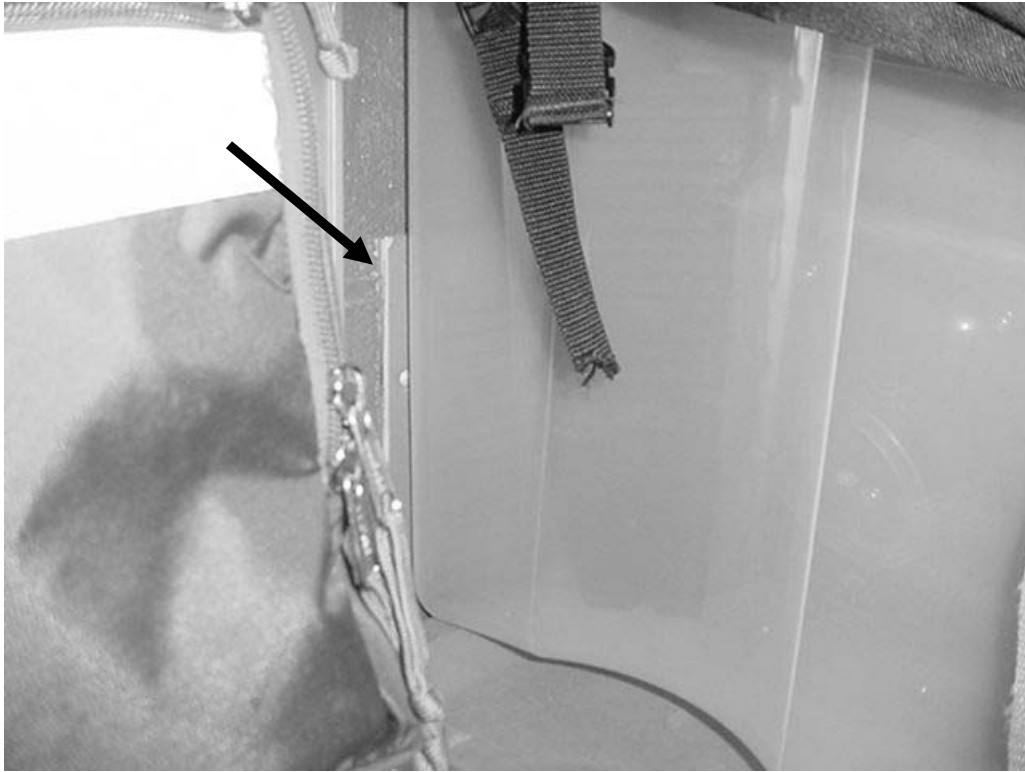
Picture 7

Exhaust Vent Completely Obstructed by Plastic Tote

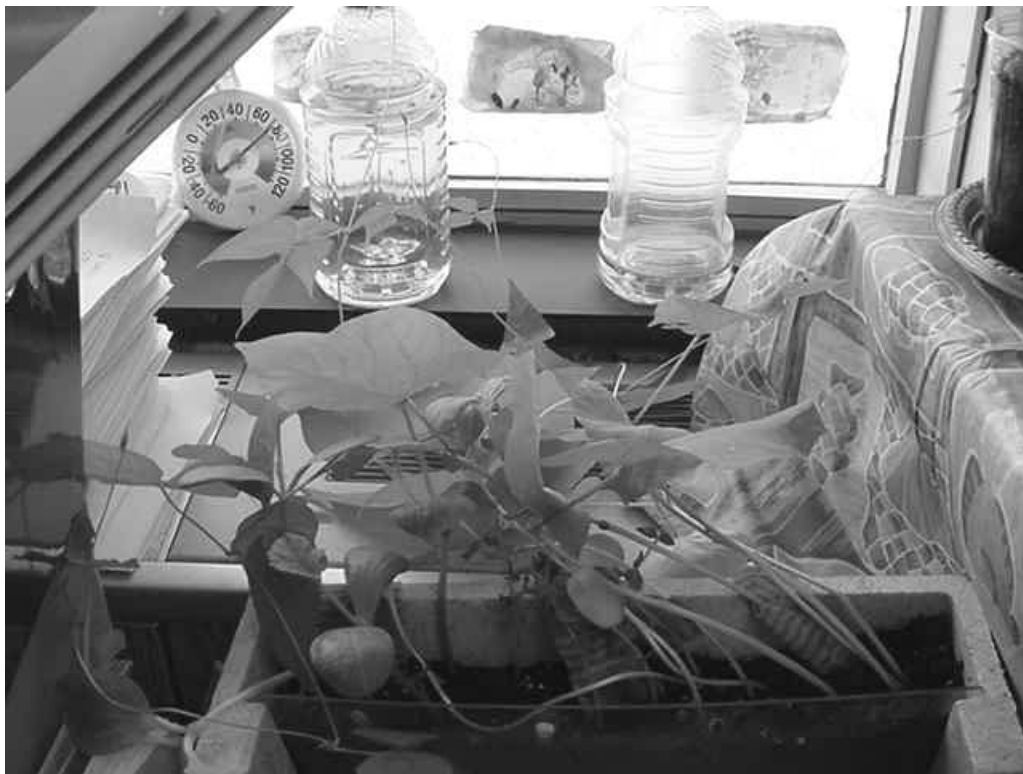
Picture 8

Plants were noted in several classrooms, and flowering plants were seen in close proximity to univent air intakes (Picture 8). Plants can be a source of pollen and mold, which can be respiratory irritants for some individuals. Plants should be properly maintained and equipped with drip pans. Plants should also be located away from ventilation sources (e.g., air intakes, univent diffusers) to prevent the entrainment and/or aerosolization of dirt, pollen or mold.

Plant on Univent near Air Diffuser

8. Ensure plants have drip pans. Examine drip pans periodically for mold growth and disinfect with an appropriate antimicrobial where necessary. Keep plants away from the air stream of univents.

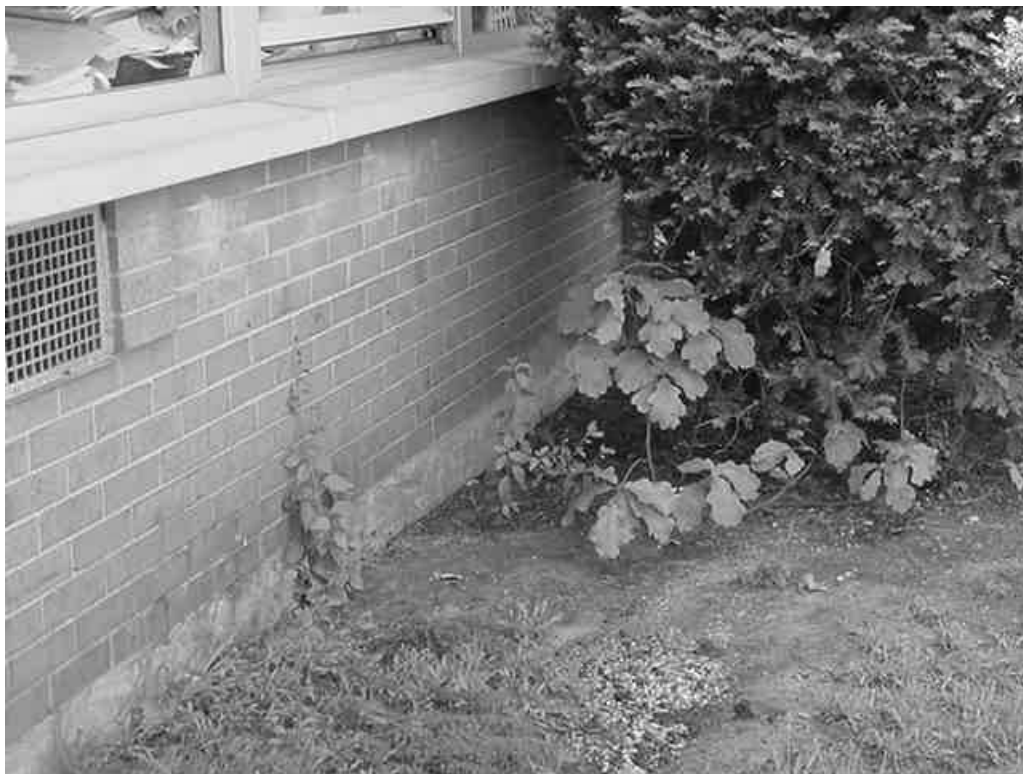
Picture 9

Plants were observed growing against exterior walls (Picture 9). The growth of roots against exterior walls can bring moisture in contact with the foundation. Plant roots can eventually penetrate, leading to cracks and/or fissures in the sublevel foundation. Over time, this process can undermine the integrity of the building envelope, providing a means of water entry into the building via capillary action through foundation concrete and masonry (Lstiburek & Brennan, 2001).

Plants/Shrubs against Exterior Brickwork

9. Clear plant growth away from the exterior of the building.
10. Inspect roof drains periodically to ensure proper drainage and prevent water pooling.
11. Contact a masonry firm or general contractor to repair breaches in exterior walls to prevent water penetration, drafts and pest entry.

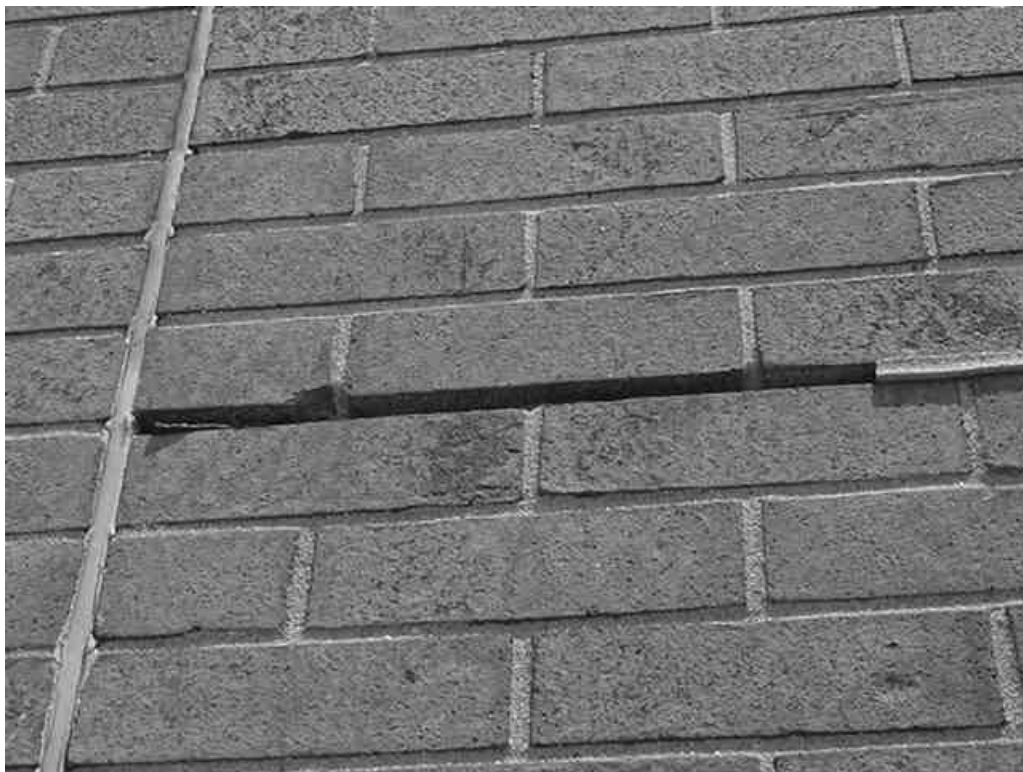
Picture 10

A number of breaches were seen around the building exterior. Missing/damaged mortar around masonry was also observed in several areas (Picture 10). Holes, breaches, and seams are points through which water can penetrate the building, particularly under driving rain conditions. Excessive exposure of the exterior brickwork and foundation to water can result in structural damage.

Missing/Damaged Mortar around Exterior Brick

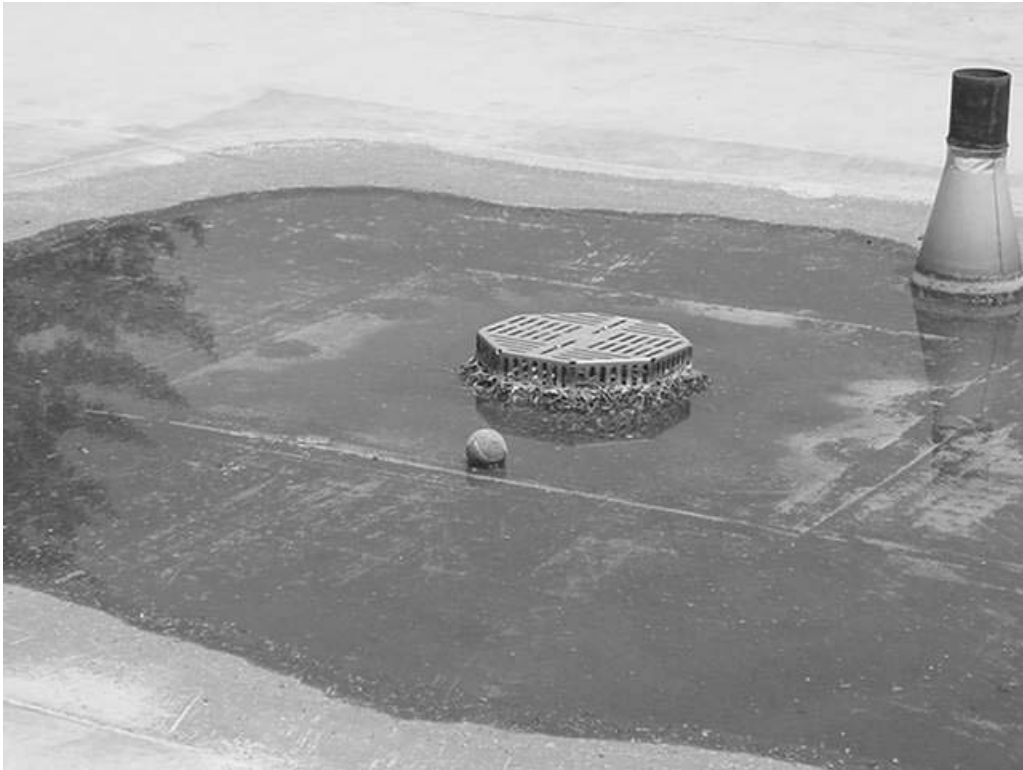
Picture 11

Pooling water was noted on the roof due to a clogged drain (Picture 11). Freezing and thawing of water during winter months can lead to roof leaks and subsequent water penetration

into the interior of the building. Pooling water can also become stagnant, which can lead to unpleasant odors and microbial growth. In addition, stagnant pools of water can serve as a breeding ground for mosquitoes.

Clogged Roof Drain and Pooling Water

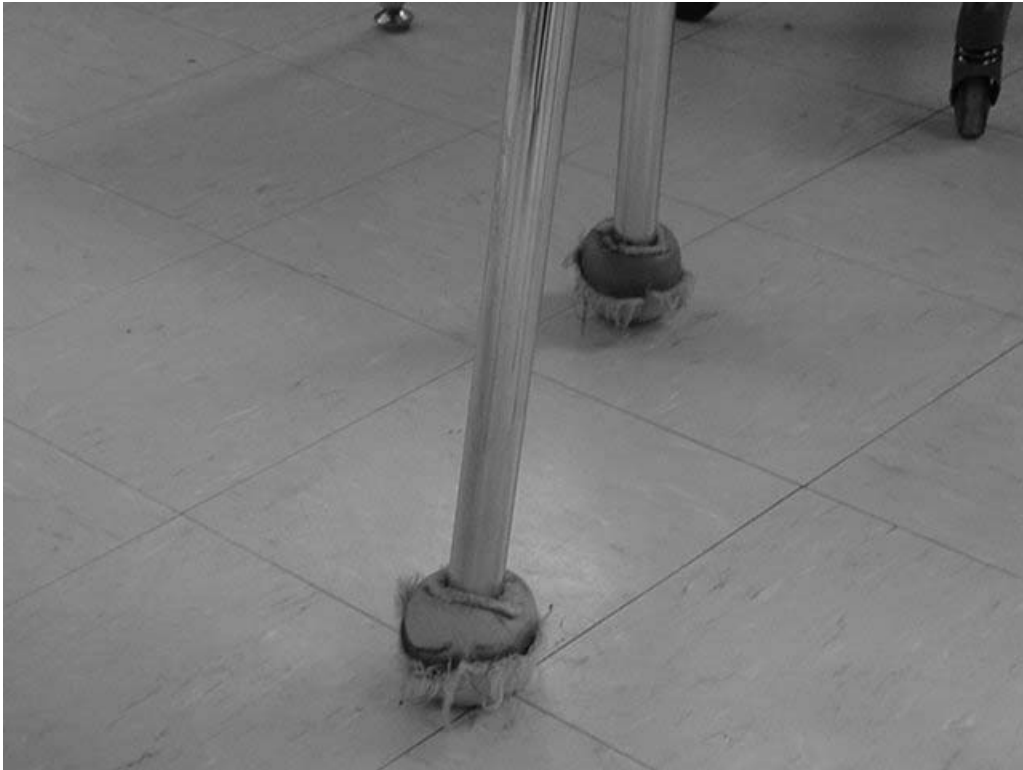
Picture 12

In an effort to reduce noise from sliding chairs, tennis balls had been sliced open and placed on chair legs (Picture 12). Tennis balls are made of a number of materials that are a source of respiratory irritants. Constant wearing of tennis balls can produce fibers and off-gas TVOCs. Tennis balls are made with a natural rubber latex bladder, which becomes abraded when used as a chair leg pad. Use of tennis balls in this manner may introduce latex dust into the school environment. Some individuals are highly allergic to latex (e.g., spina bifida patients) (SBAA, 2001). It is recommended that the use of materials containing latex be limited in buildings to reduce the likelihood of symptoms in sensitive individuals (NIOSH, 1997). A question and answer sheet concerning latex allergy is attached as Appendix B (NIOSH, 1998). Consideration should be given to replacing tennis balls with alternative glides (Picture 13).

Tennis Ball on Chair Leg

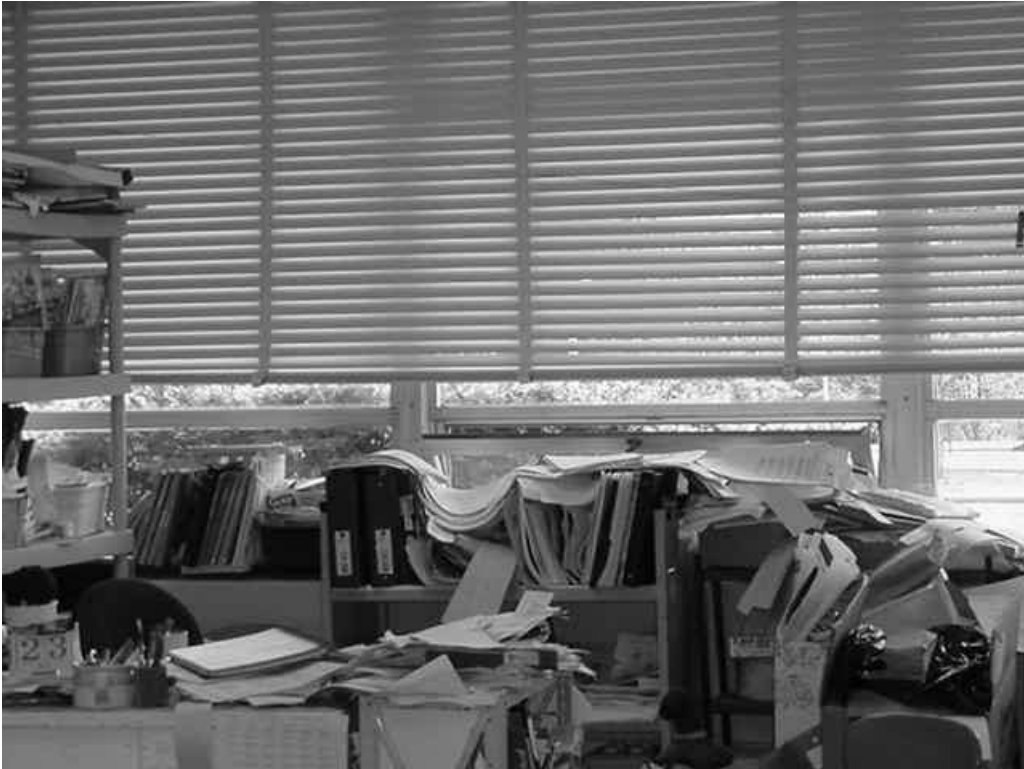
Picture 14

difficult for custodial staff to clean. Items should be relocated and/or be cleaned periodically to avoid excessive dust build up.

Accumulated Items in Classroom

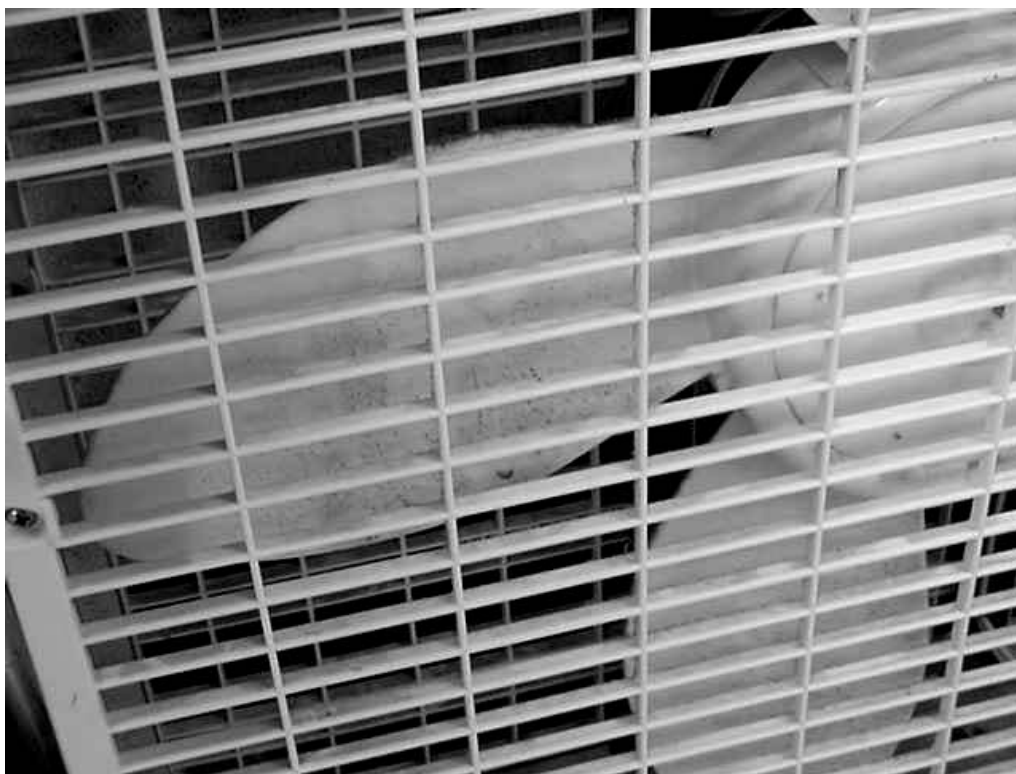
Picture 15

A number of exhaust/return vents and personal fans were observed with accumulated dust (Picture 15). If exhaust vents are not functioning, backdrafting can occur, which can re-aerosolize dust particles. In addition, these materials can accumulate on flat surfaces (e.g., desktops, shelving and carpets) in occupied areas and subsequently be re-aerosolized causing further irritation. Dust can be irritating to eyes, nose and the respiratory tract. Accumulated chalk dust was noted in some classrooms. Chalk dust is a fine particulate, which can be easily aerosolized and is an eye and respiratory irritant.

Accumulated Dust on Fan Blades

15. Clean accumulated dust from exhaust vents and blades of personal fans.
16. Clean chalkboard/dry erase marker trays regularly to prevent the build-up of excessive chalk dust and particulates.

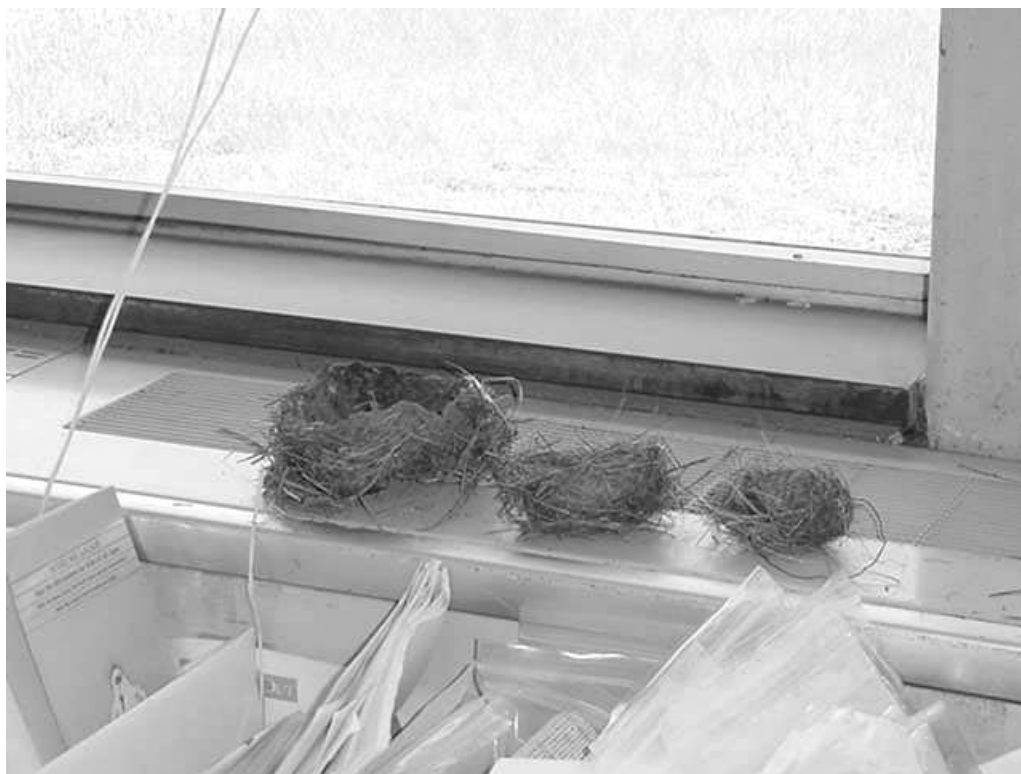
Picture 16

In one classroom, a birds' nest was observed on the univent (Picture 16). Nests can contain bacteria and may be a source of allergenic material. Nests should be stored in sealed bags to prevent aerosolization of allergenic material or discarded.

Birds Nests on Univent near Air Diffuser

17. Store cleaning products properly and out of reach of students.
18. Store nests in re-sealable bags to prevent aerosolization of irritants.
19. Refrain from using food as materials for projects or seal in bag/container to prevent pest attraction.

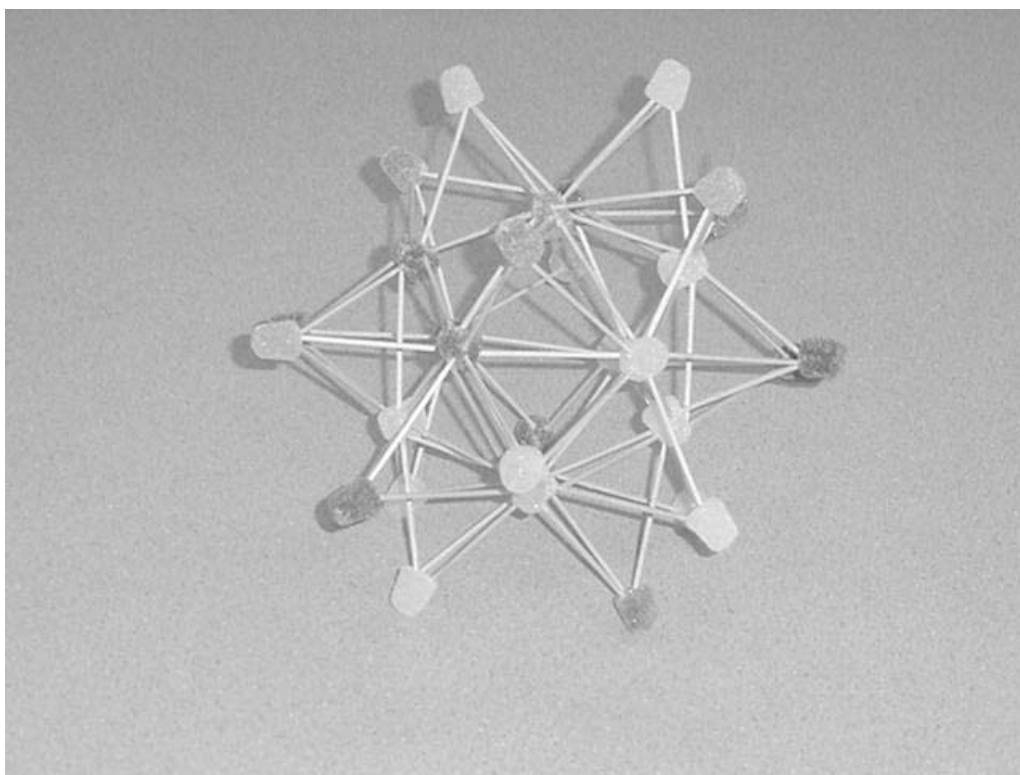
Picture 17

Finally, of note was the use of food as school project materials (Picture 17). Exposed food products and reused food containers can attract a variety of pests. The presence of pests inside a building can produce conditions that can degrade indoor air quality. For example, rodent infestation can result in symptoms due to materials in their wastes. Mouse urine is known to contain a protein that is a known sensitizer (US EPA, 1992). A sensitizer is a material that can produce symptoms in exposed individuals, including respiratory irritations and skin rashes. Pest attractants should be reduced/eliminated. Proper food storage is an integral component in maintaining indoor air quality. Food should be properly stored and clearly labeled. Reuse of food containers (e.g., for art projects) is not recommended since food residue adhering to the container surface may serve to attract pests.

Candy Gum Drops Used for School Projects
